The Tetra Tech Superfund Technical Assessment and Response Team (START) is pleased to submit the draft Emergency Response Letter Report summarizing emergency response activities conducted at the Wingate Farms Pesticide Response (TDD No. TTEMI-05-001-0196) located in Leesburg, Georgia.

**Subject: Draft Emergency Response Letter Report  
Wingate Farms Pesticide Site  
Leesburg, Lee County, Georgia  
EPA Contract No. EP-W-05-054  
TDD No. TTEMI-05-001-0196**

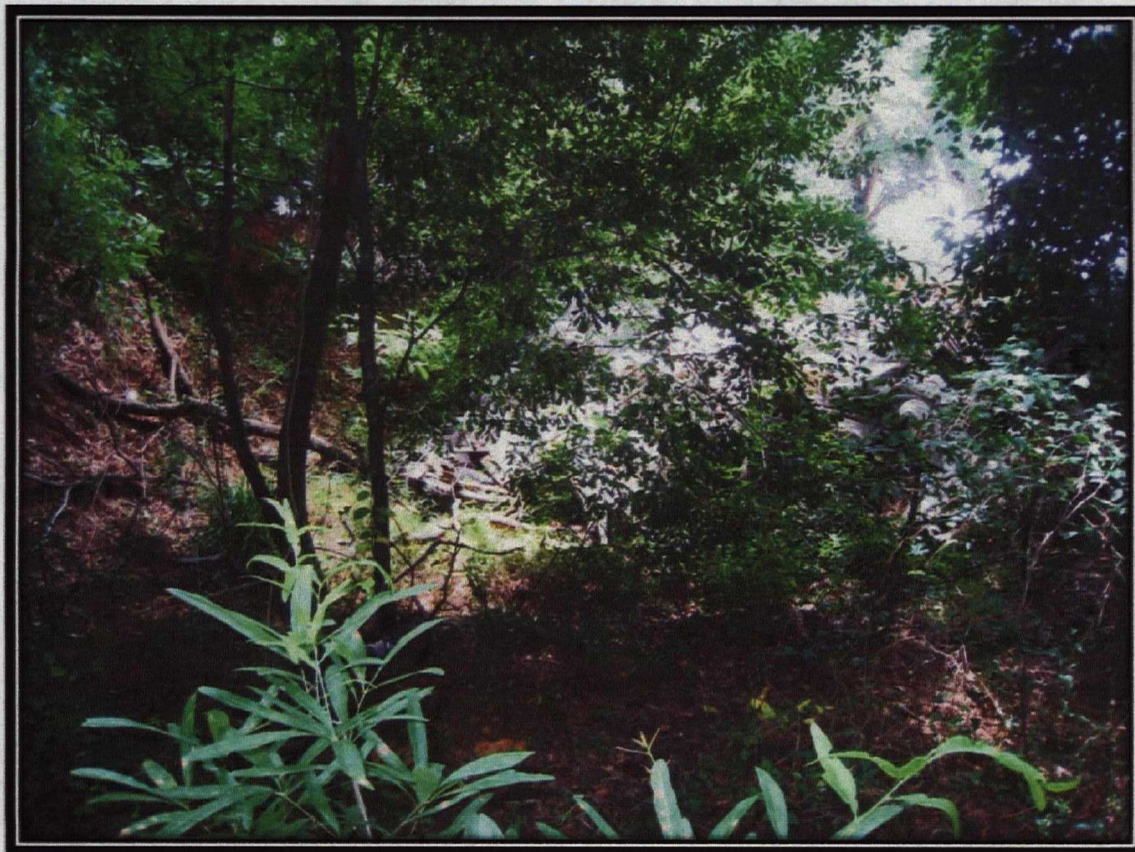
**OFFICIAL PHOTOGRAPH NO. 33**  
**U.S. ENVIRONMENTAL PROTECTION AGENCY**

**Subject:** Area downgradient and northeast of the Household trash dumping area; two soil borings were advanced in this area to see if buried trash was present. No sheen, staining, odors or evidence of buried trash was encountered.

Two open pit dumps were observed on site. One location appeared to contain household trash and the other contained white canvas peanut bags. Tetra Tech START was tasked with hand augering soil borings in an area downgradient and northeast of these open dump areas to determine whether trash had been buried. Boreholes were extended to groundwater, which was encountered at approximately 24 inches below ground surface. No sheen, staining, odors or evidence of buried trash was observed.
